# **Pentium<sup>®</sup> II Processor Specification Update**

Release Date: September 1997

Order Number: 243337-005

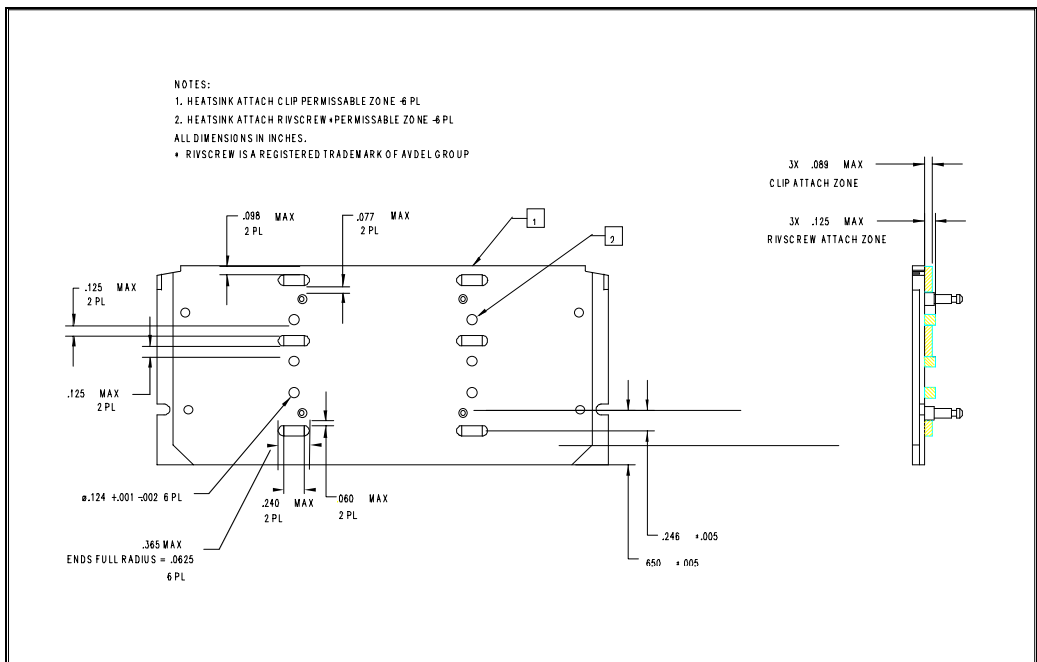
**Figure 12. Heatsink Attachment Mechanism Design Space**

A change to the attach mechanism specification is provided below. The original specification for clearance of heatsink attach solutions is provided in Section 4.3 (and Figure 23 and Figure 24) in the *Pentium® II Processor at 233 MHz, 266 MHz and 300 MHz* datasheet. Figure 11 shows the revised maximum specifications for heatsink clip and Rivscrew® attach mechanism designs. All heatsink clip and Rivscrew attachment solutions must remain within the respective maximum “permissible” zone as detailed in Figure 11.

The thermal plate shown in Figure 11 is used to portray the heatsink attach mechanism design space for the future Slot 1 processors. However, the maximum “permissible” design space is also valid for both the current Pentium II and future Slot 1 processors.

Please review the proposed specifications to guarantee compatibility with existing Pentium II and future Slot 1 processor heatsink attachment solutions. Note that the required heatsink attachment solution space should not exceed the maximum proposed design space while installed or during the installation and removal procedure.
